Recent Tevatron Operations + Last Week's Failure in D3

Ron Moore

Fermilab – Tevatron Dept.

Component Failure in D3

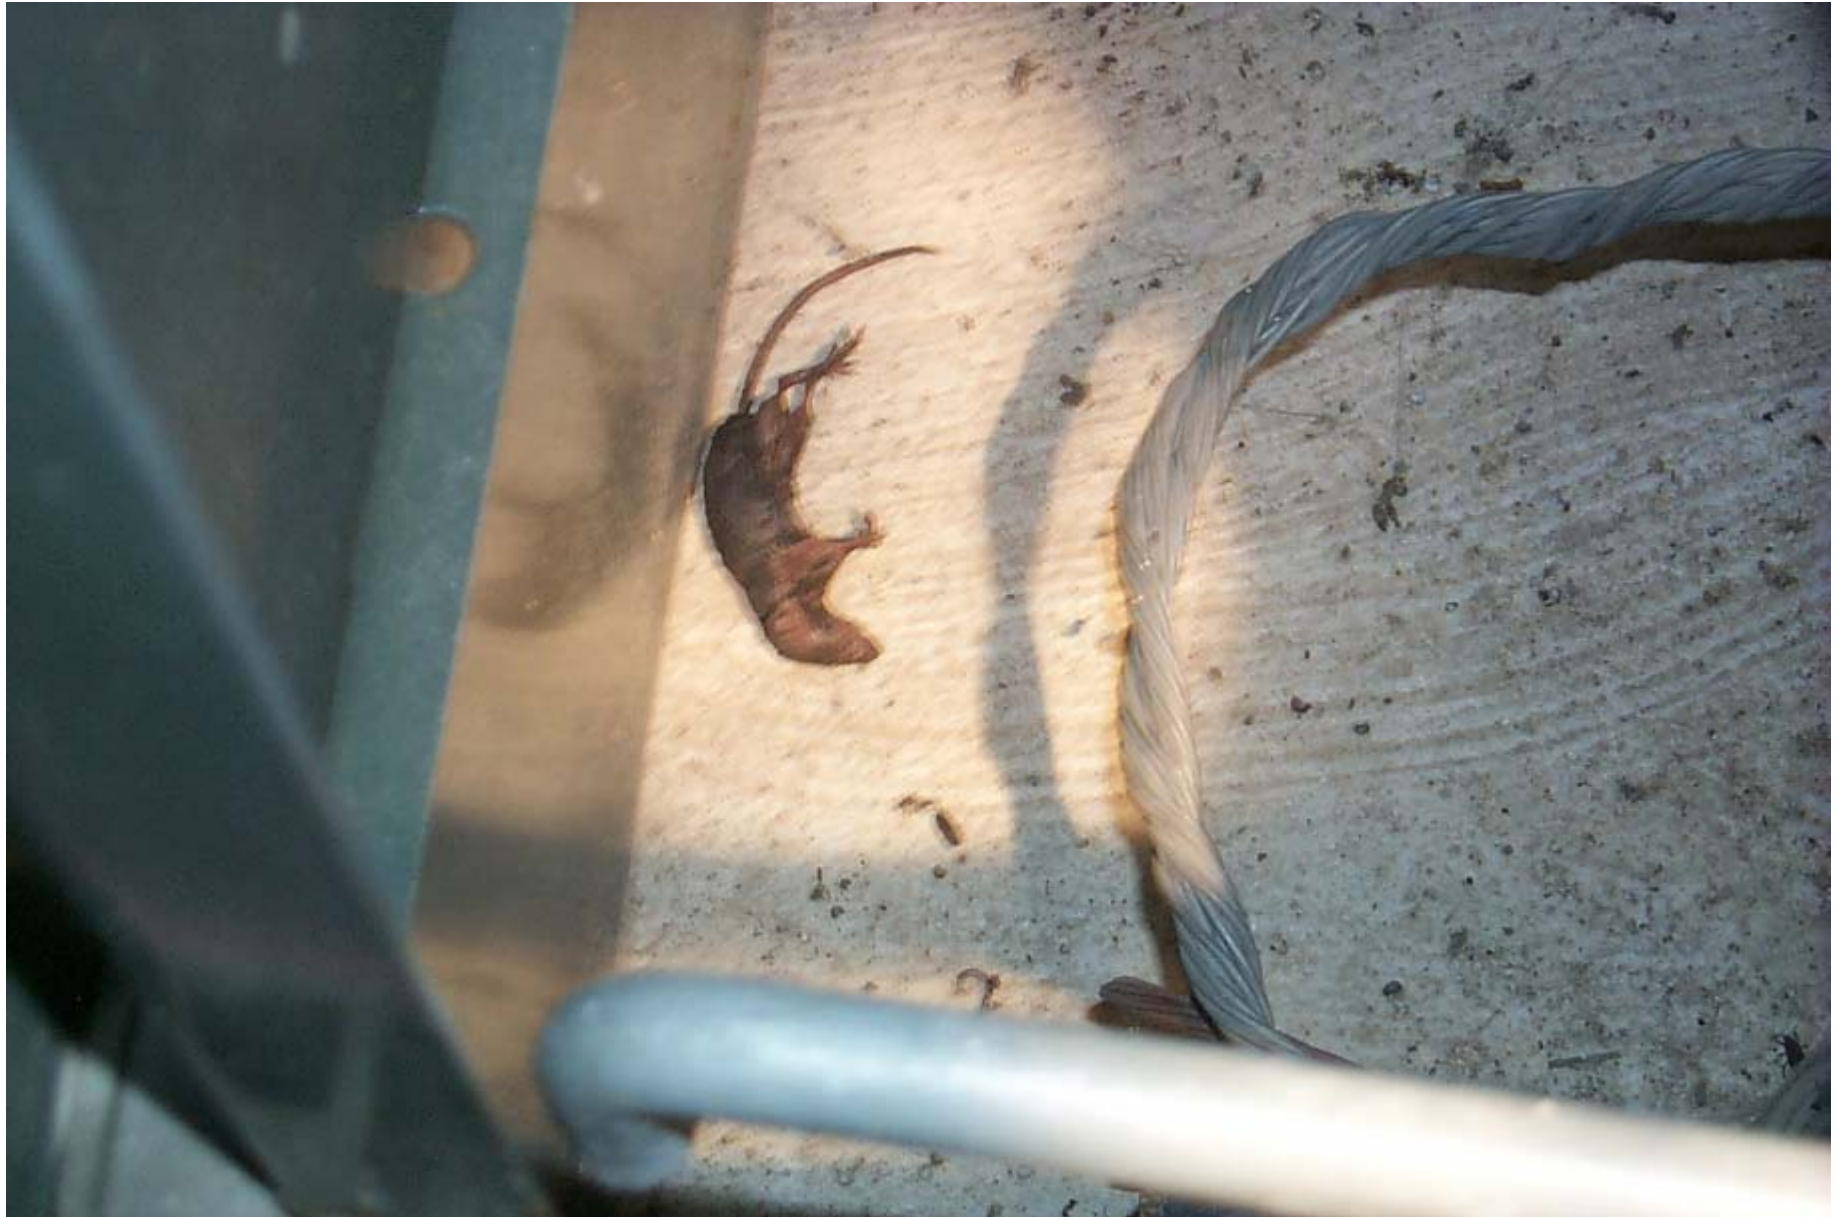
The Culprit

- HEP store 5008 happily spinning
 - Record # pbars injected into Tev, record # pbars reach HEP start
- Mouse seeks Feeder 46B cubicle as possible new, cozy home
 - Flashover + resulting nasty power glitch affects many systems
 - Many UPS units switched over
- Tevatron ramp begins to dump on A2 power supply trip
 - Beams aborted cleanly
- 1.2 sec into ramp dump, D3 QPM reboots (Quench Protection Monitor)
 - Why? Glitch not filtered out by UPS? UPS tested fine later...
 - As designed, QPM fired heaters, generating whole-house quench
- ≈ 4 sec into ramp dump, ground fault developed in D3
 - D32-5 dipole failed
